WARTIME REPORT

AN INVESTIGATION OF A THERMAL ICE-PREVENTION SYSTEM
FOR A C-46 CARGO AIRPLANE

III - DESCRIPTION OF THERMAL ICE-PREVENTION EQUIPMENT
FOR WINGS, EMPENNAGE, AND WINDSHIELD

By Alun R. Jones and Ray J. Spies, Jr.

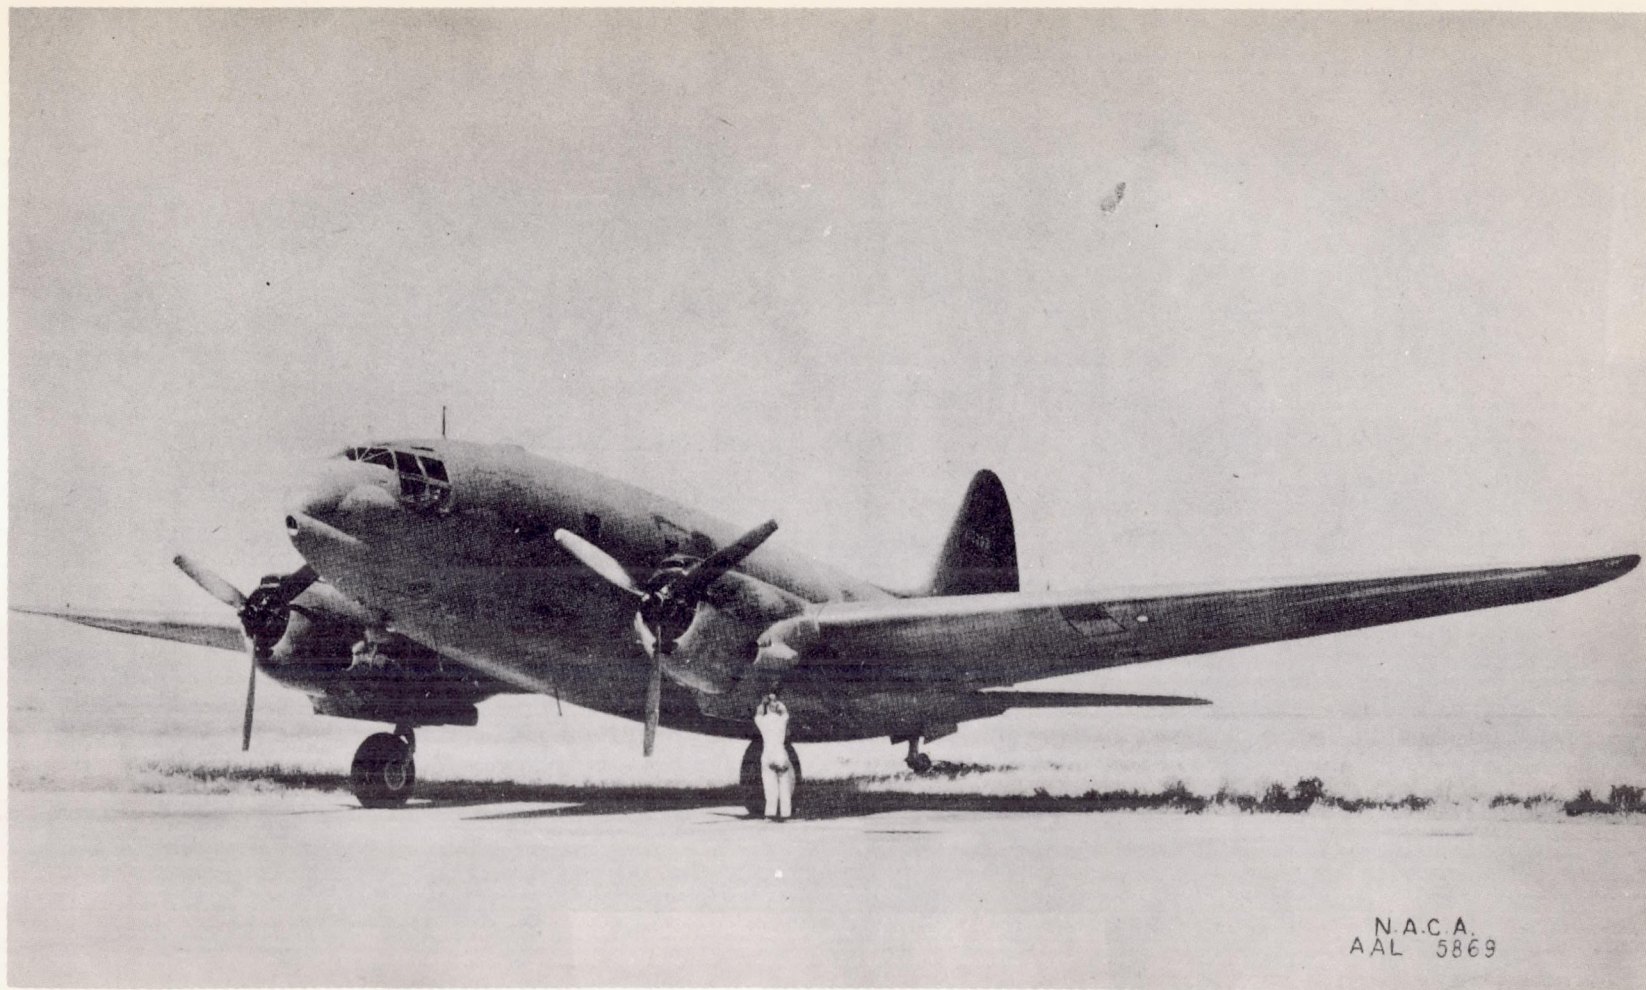
Figure 1.- The C-46 airplane for which the NACA designed and installed thermal ice-prevention equipment for the wings, empennage, and windshield.

The C-46 airplane (fig. 1) is a twin-engine low-wing monoplane of the heavy cargo type powered by two Pratt and Whitney Model R-2800-51 engines having a sea-level rating of 2000 horsepower each.

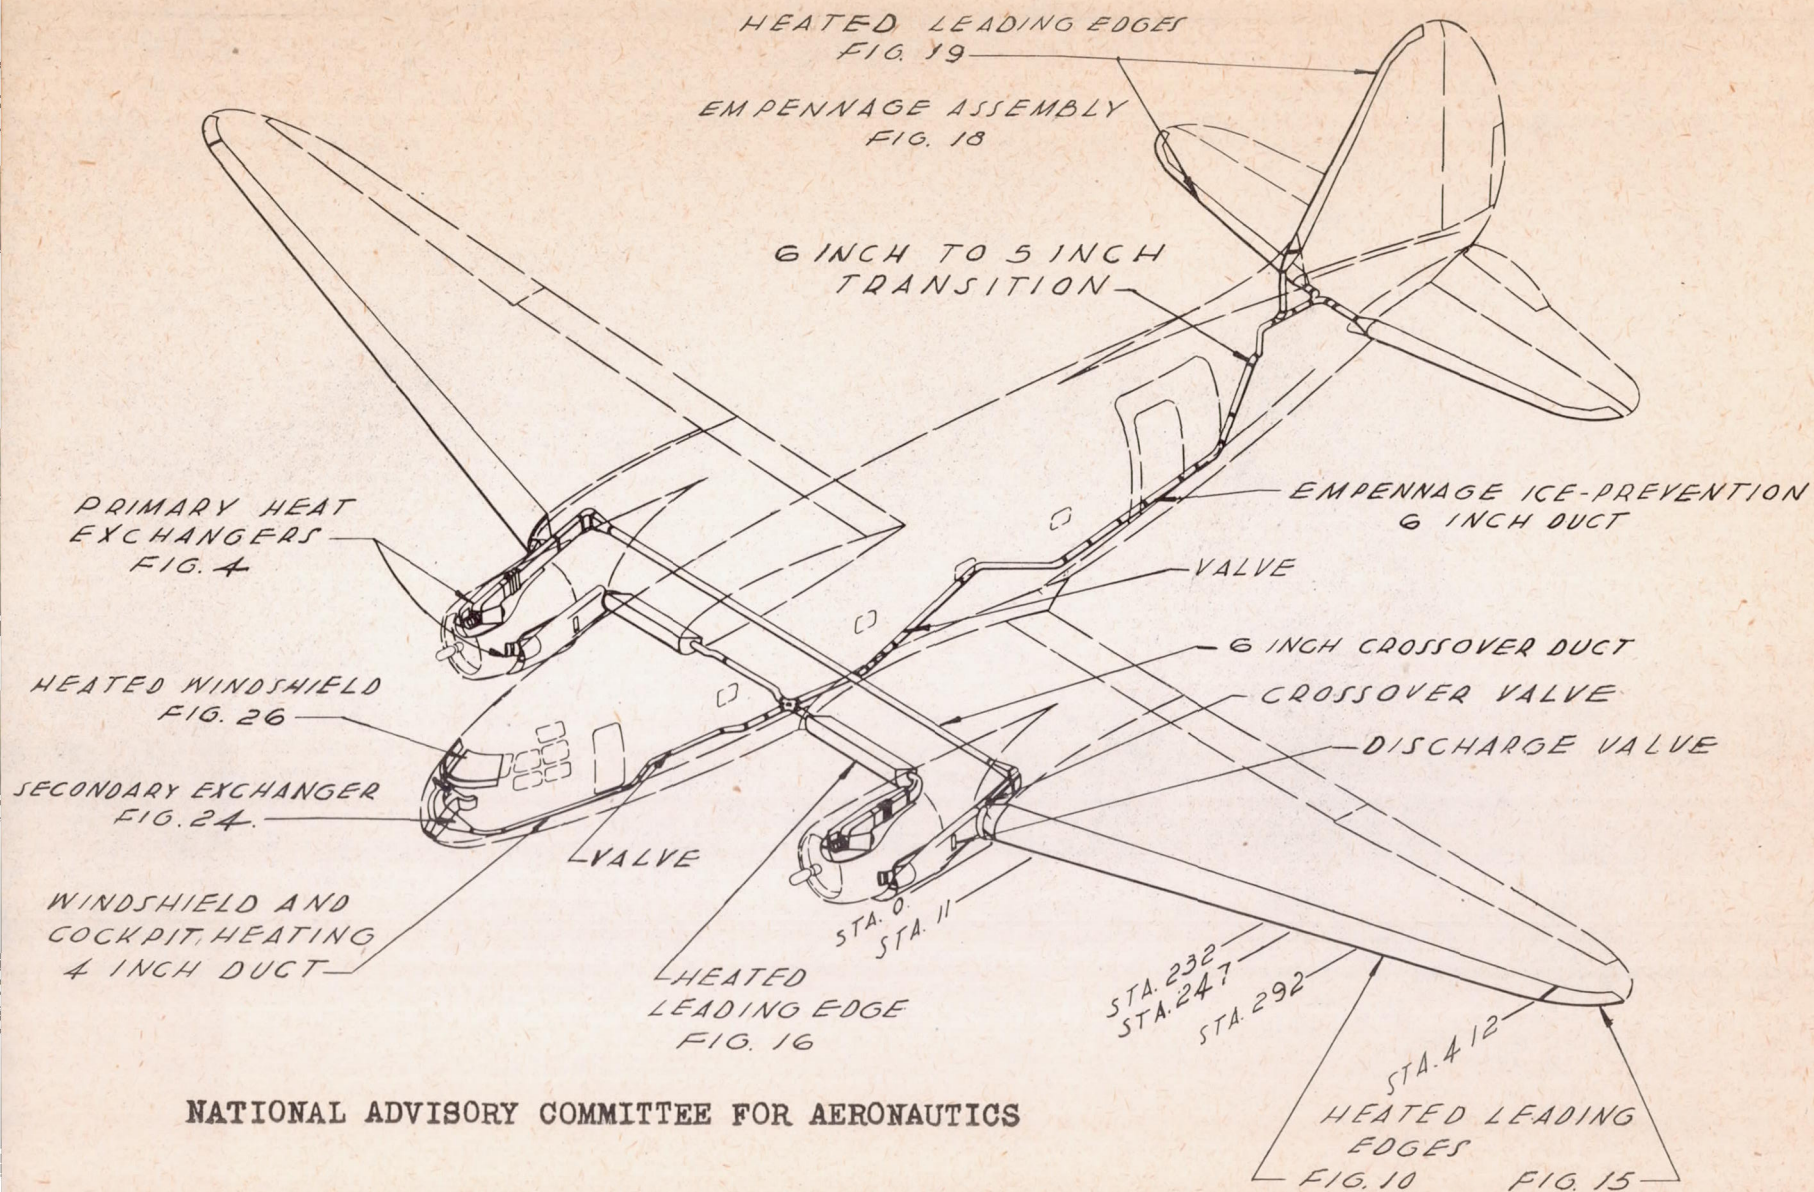
FIGURE 2- GENERAL ARRANGEMENT OF THERMAL ICE-PREVENTION EQUIPMENT IN C-46 AIRPLANE.

The general arrangement of the airplane as revised for thermal ice prevention is shown in figure 2. The ice-prevention system is based upon the transfer of heat from the engine exhaust gas to air which is then caused to flow along the inner surface of any portion of the airplane for which protection is desired. In the application of this principle to the C-46 airplane, the necessary heat is removed from the exhaust gas by means of two exhaust-gas-to-air heat exchangers installed in each nacelle, as shown in figure 2. The heated air from the outboard exchangers is used to provide ice protection for the wing outer panels and tips. The inboard exchangers supply heated air for heating of the cockpit and for the prevention of ice formations on the wing inboard panels, empennage, and windshield.

The heated-air-distribution system is shown in figure 2. No blowers are installed in the primary-air system, the circulation of the air depending upon the ram available at the exchanger air inlets and the pressure conditions at the discharge locations. In the case of the outboard exchangers, the air is admitted to the wing outer-panel ice-prevention system at a point just outboard from the nacelle. For single-engine operation of either engine, the heated air can be divided between the right- and left-wing outer-panel systems by operation of crossover valves located as shown in figure 2.

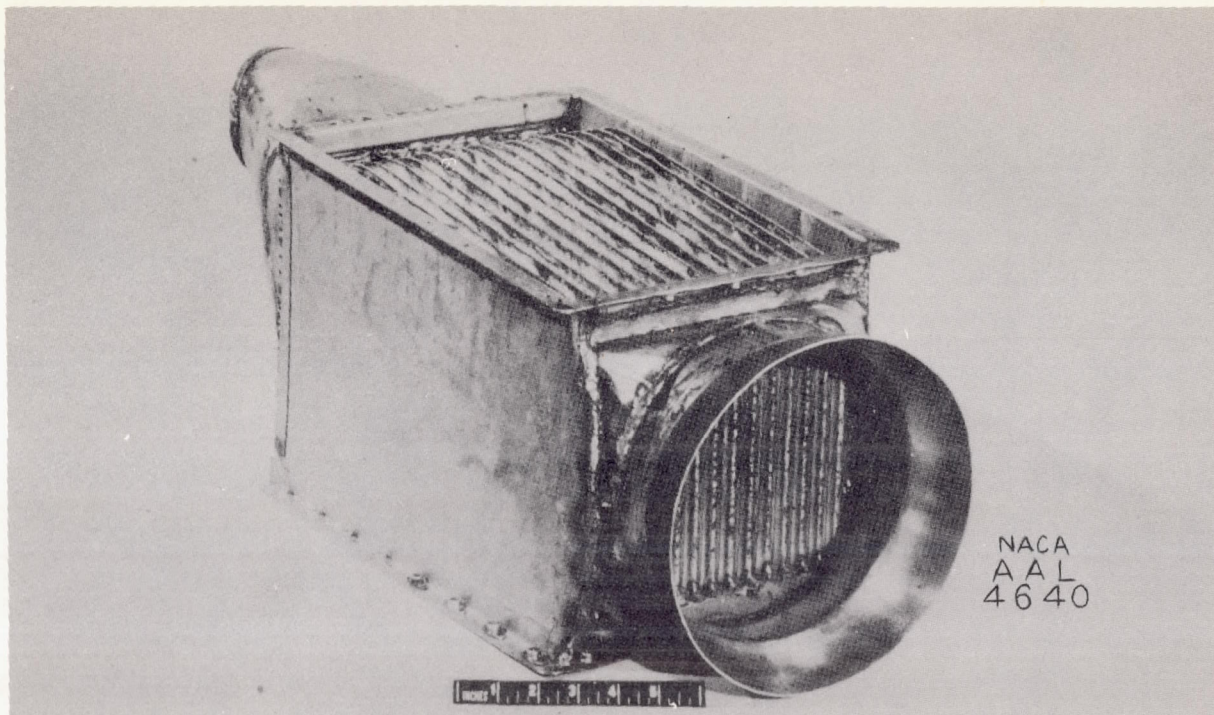
Figure 3.- Cross-flow plate-type exhaust gas-air heat exchanger as installed on C-46 airplane viewed from exhaust inlet side.

The exhaust-gas-to-air heat exchangers installed on the airplane are of the flat-plate cross-flow type and are shown in figure 3. They were fabricated from sheets of Inconel pressed into the required shape and welded together along the edges. At the forward end of the exchanger, all the plates are welded together and also to the exhaust-gas inlet. At the rear of the exchanger, however, the two outer plates are not attached to the inner plates or to the gas outlet, thus allowing the inner core to expand independent of the outer cooler plates. The gas outlet is attached to the inner group of plates. The plates, approximately 9 inches by 15 inches, are assembled to form 17 air passages 0.21 inch wide and 16 exhaust-gas passages 0.28 inch wide. A more complete description of the exchanger, the design analysis, and the results of preliminary flight tests are presented in reference 2.

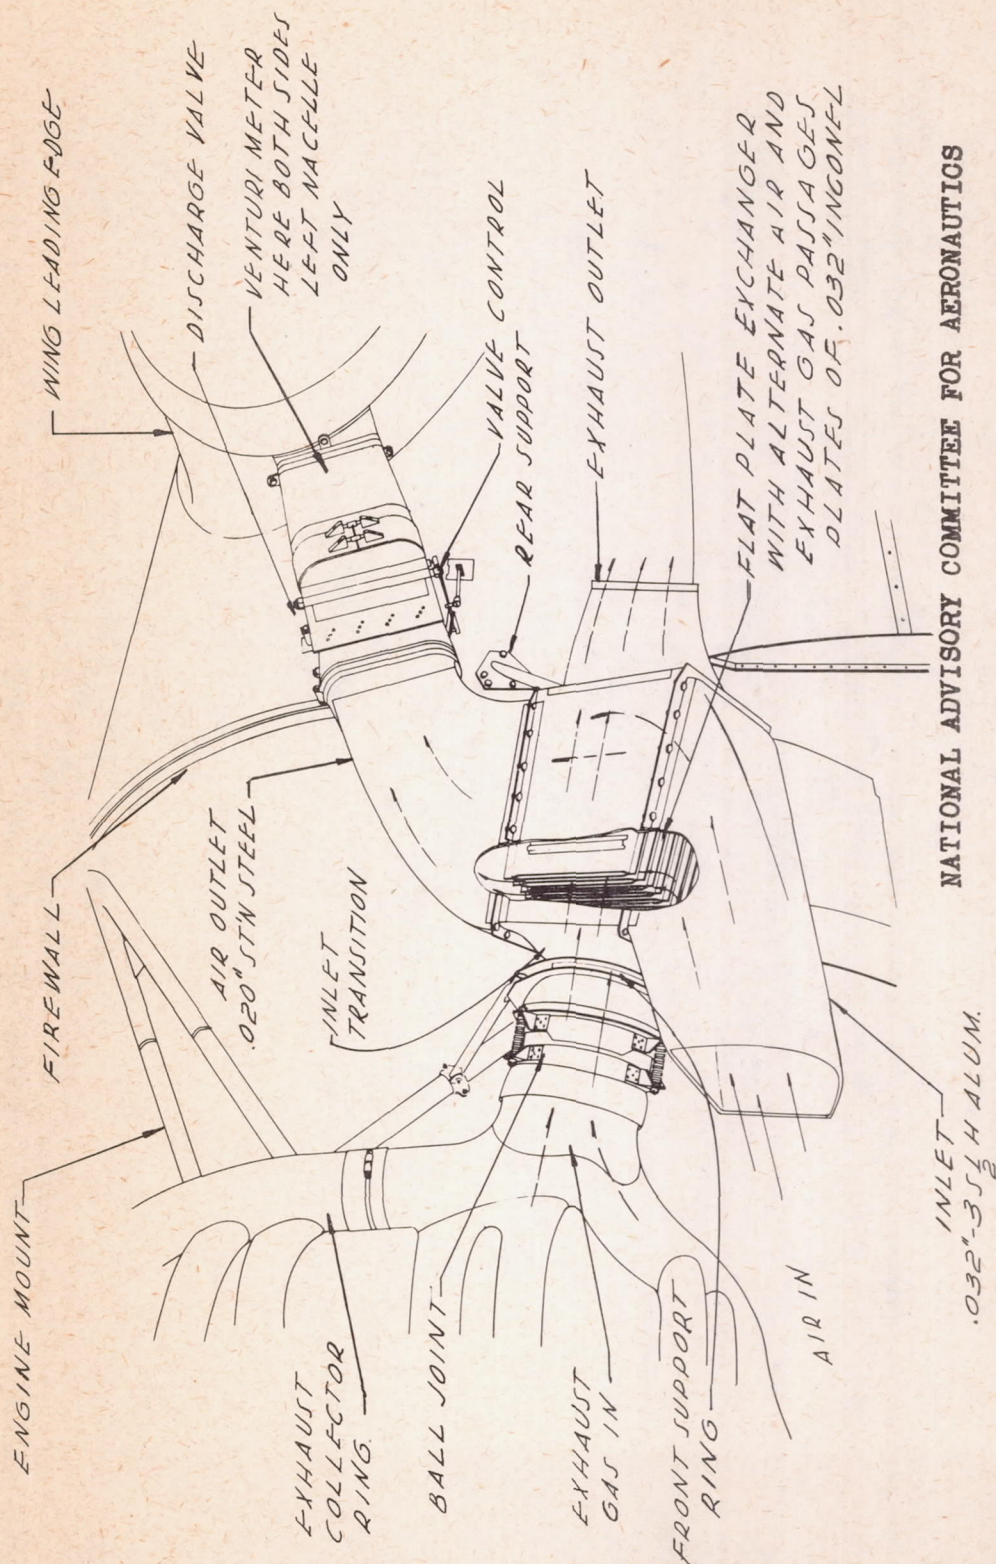
FIGURE 4:- DETAILS OF HEAT-EXCHANGER INSTALLATION ON C-46 AIRPLANE SHOWING PATHS OF EXHAUST GAS AND AIR FLOW

The heat-exchanger installation is shown in figure 4. The forward end of the exchangers was rigidly attached to the engine mount by a yoke-type clamp; therefore, a universal joint was required between the exhaust-gas collector rings and the heat exchangers to compensate for relative motion between the collector rings and engine mounts. The exchangers were supported at the rear end with a channel-and-lug arrangement which allowed the exchanger inner plates and exhaust outlets to expand rearward for about 1/4 inch. The revised collector ring and the exchanger supports for the right outboard installation are shown in figure 5. The air-inlet scoops and outlets attach directly to the exchangers, as shown in figures 4 and 6. Valves for the purpose of directing the heated air to the ice-prevention system or discharging it to the free stream were installed immediately after the exchanger air outlets. The discharge valves and outlets were fabricated from stainless steel as a precautionary measure in the event of exchanger failure. The heated-air ducts from the discharge valves to the leading edge of the wing were fabricated of aluminum and, in the case of both sides

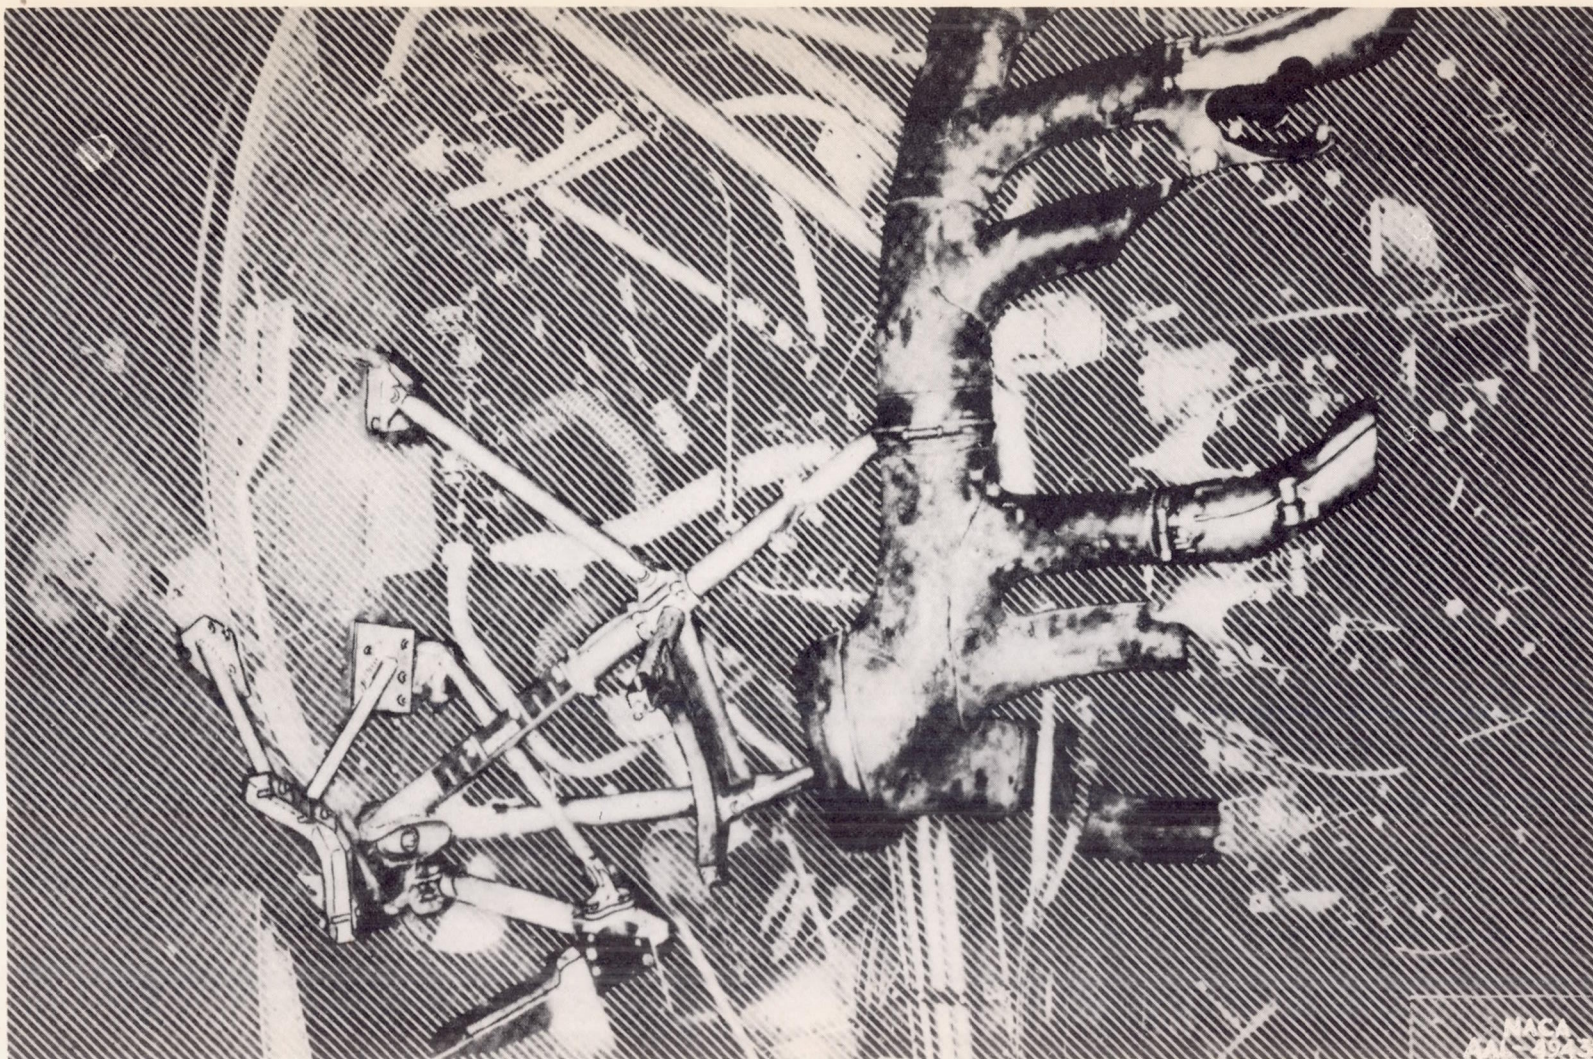
Figure 5.- Heat-exchanger supports and revised collector ring at outboard side of right nacelle, C-46 airplane.

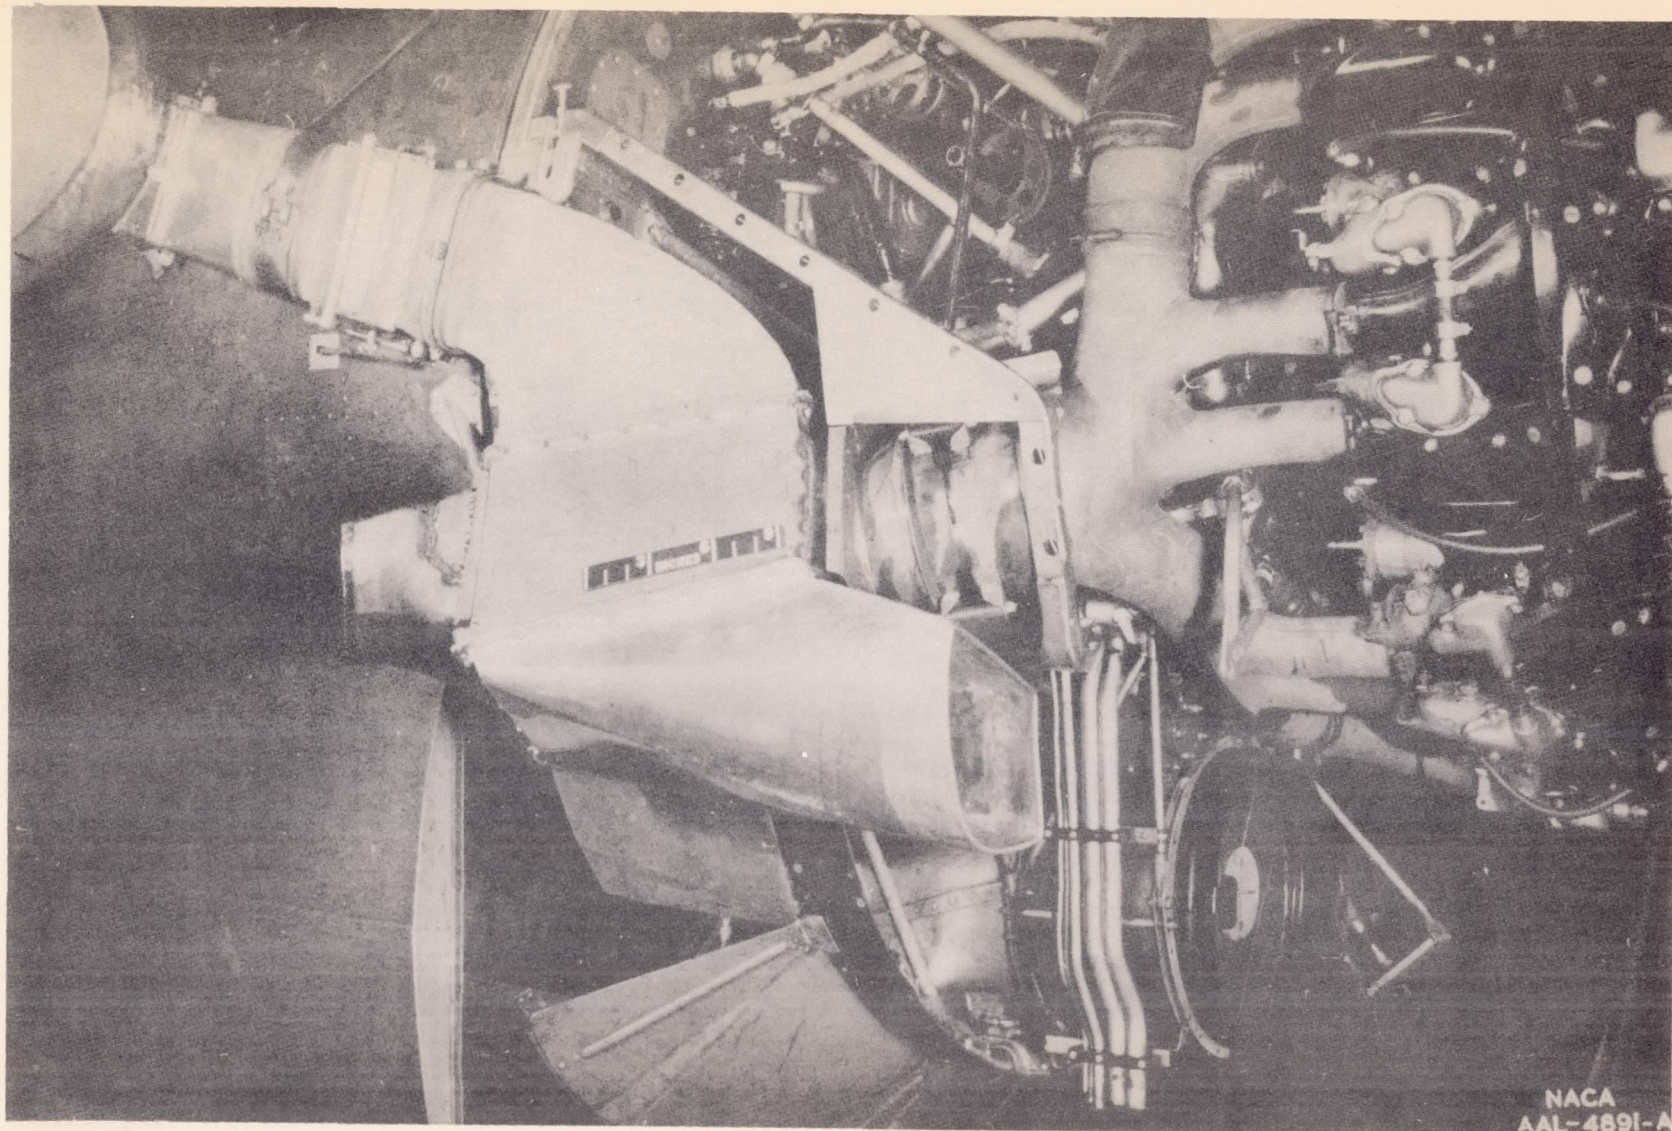
Fig. 6

Figure 6.- Right outboard heat-exchanger installation on C-46 airplane.

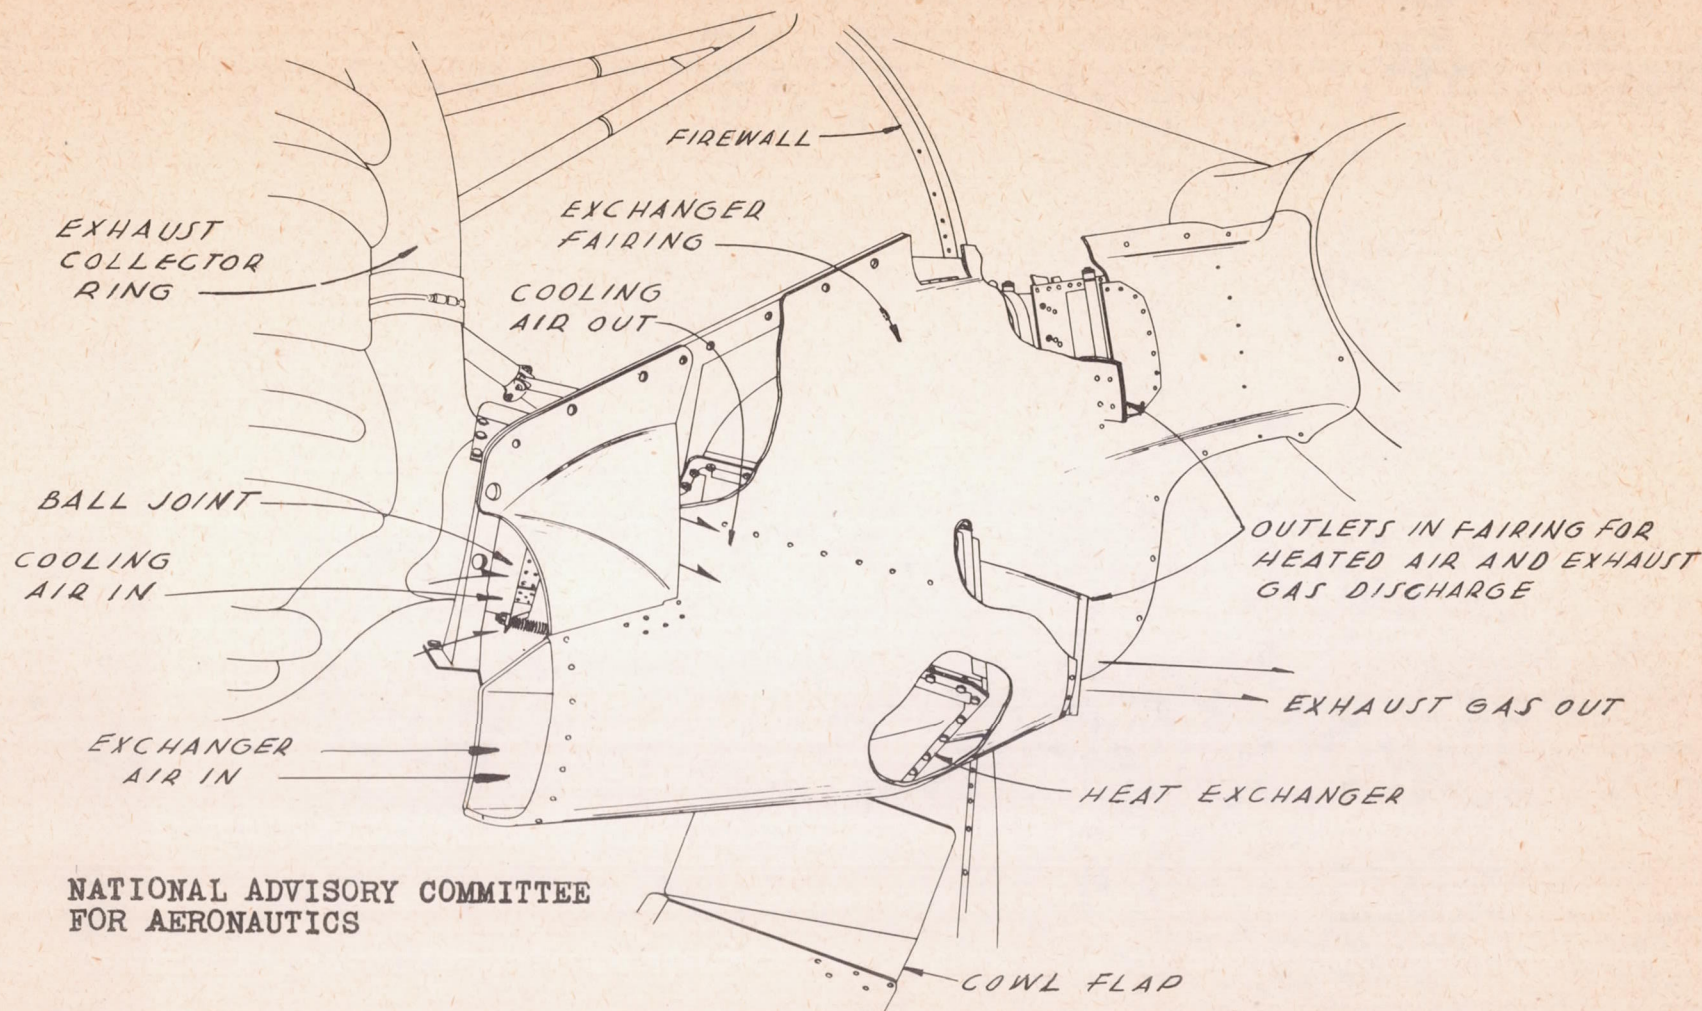
FIGURE : 7 — DETAILS OF HEAT EXCHANGER FAIRING AND BALL JOINT COOLING AIR SCOOP, C-46 AIRPLANE

The shrouding of the exchanger installation is shown in figures 7, 8, and 9. The entire exchanger assembly up to the wing leading edge is covered by a single fairing containing outlets for the exhaust-gas and heated-air discharge. A cooling-air system for the universal ball joint was incorporated in the design in order to prolong the service life of the joint. This system is shown diagrammatically in figure 7 and consists of a shroud around the inner side of the ball joint forming a 1-inch annular space, between the shroud and the joint, through which cooling air is circulated. The cooling-air inlet scoop and discharge are formed from one piece and are shown in the completed installation (figs. 7 and 9).

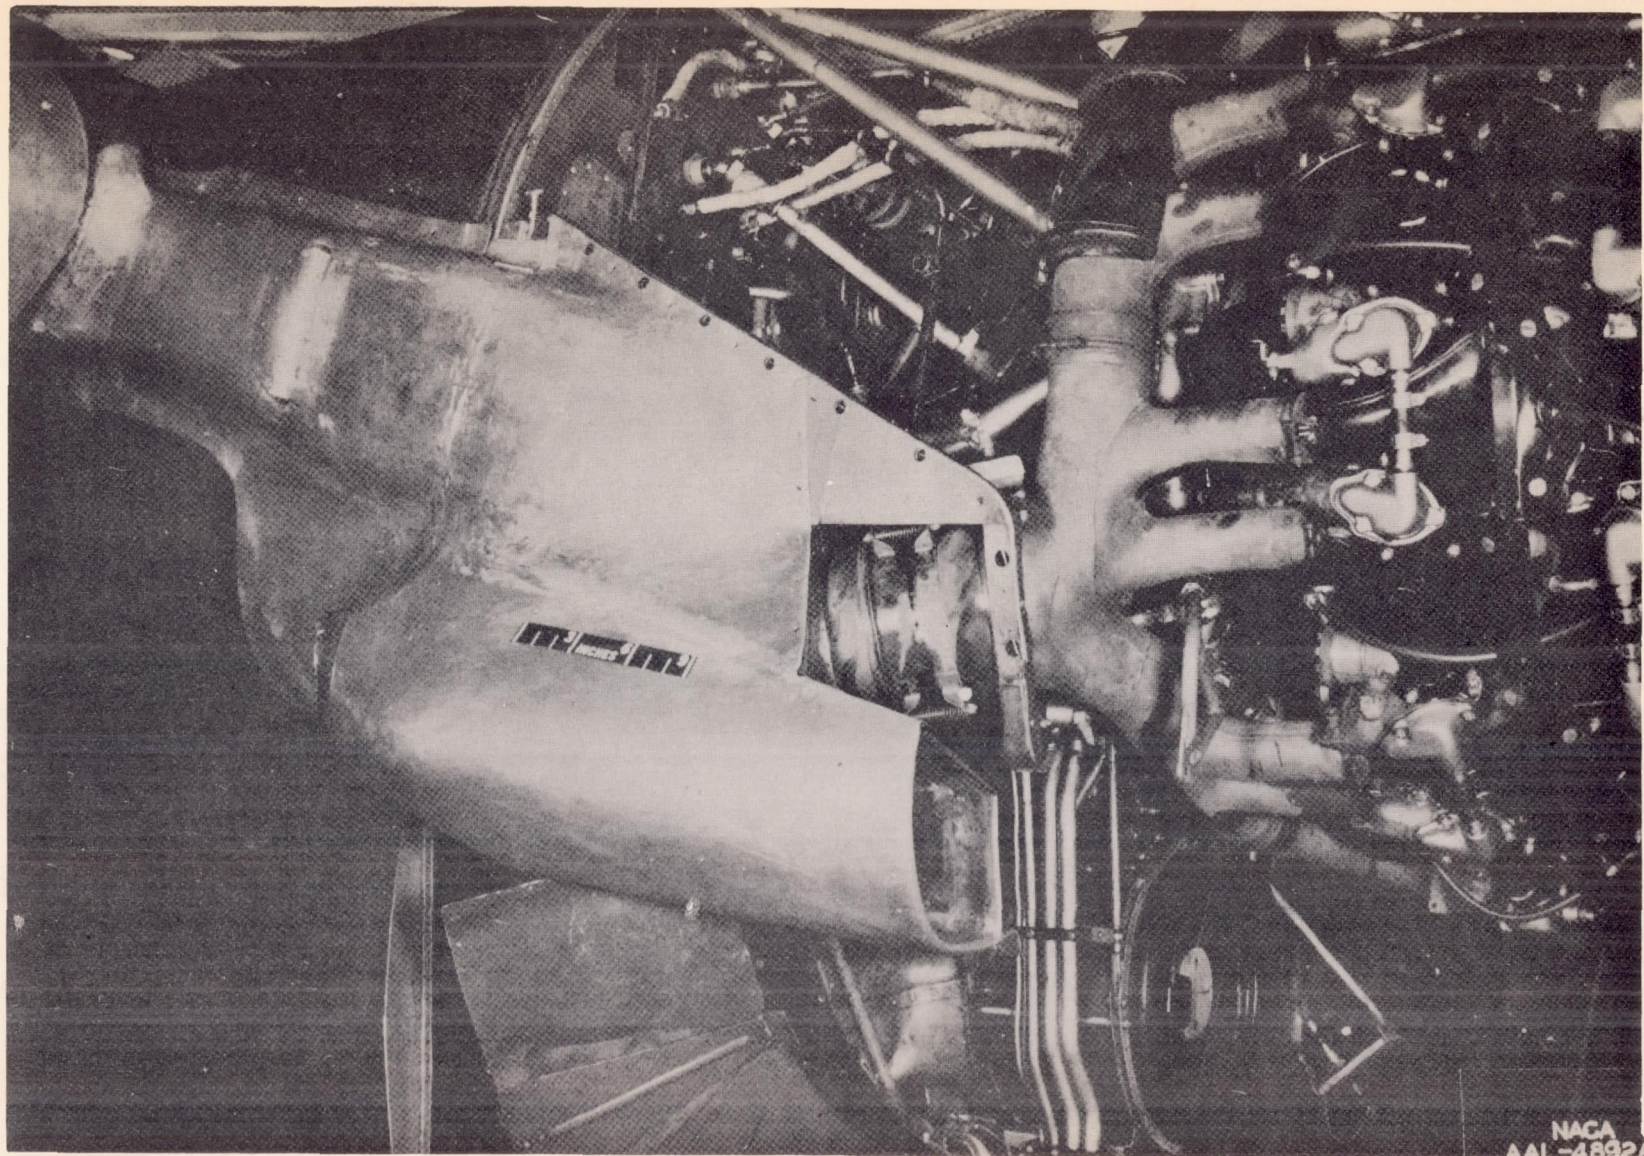
Figure 8.- Heat-exchanger shroud installed on outboard side of right nacelle, C-46 airplane.

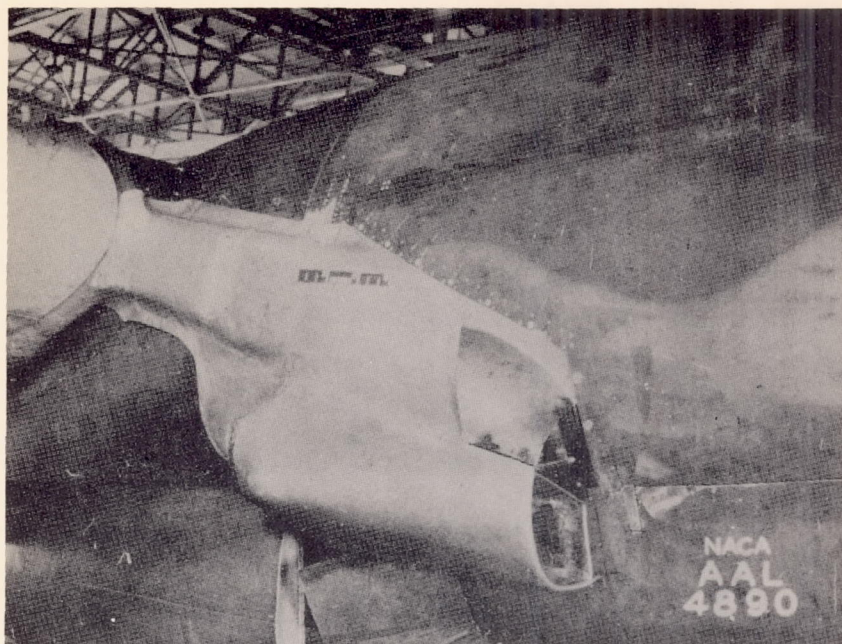
Figure 9.- Right outboard heat-exchanger installation on C-46 airplane ready for flight.

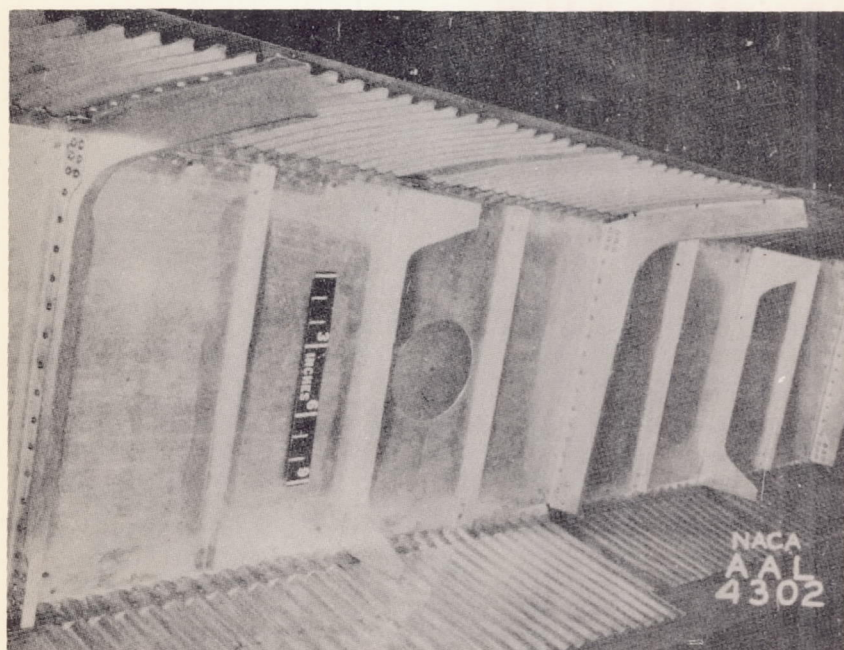
Figure 12.- Rear view of 5.5-percent-chord baffle plate installed in wing outer-panel leading edge, C-46 airplane.

A rear view of the baffle plate installed in the wing leading edge is shown in figure 12. The L-shape stiffeners

shown are located behind the intermediate nose ribs and attach to the spanwise hat-section member located on the upper surface of the wing (fig. 10). The stiffeners shown midway between the L sections are also located behind nose ribs and are attached to the wing main ribs as shown in figure 13. The extruded angle bolted through the baffle plate to an identical angle on the nose rib, and the end of the corrugated inner skin, beveled to provide a larger exit area, may also be seen in figure 13.

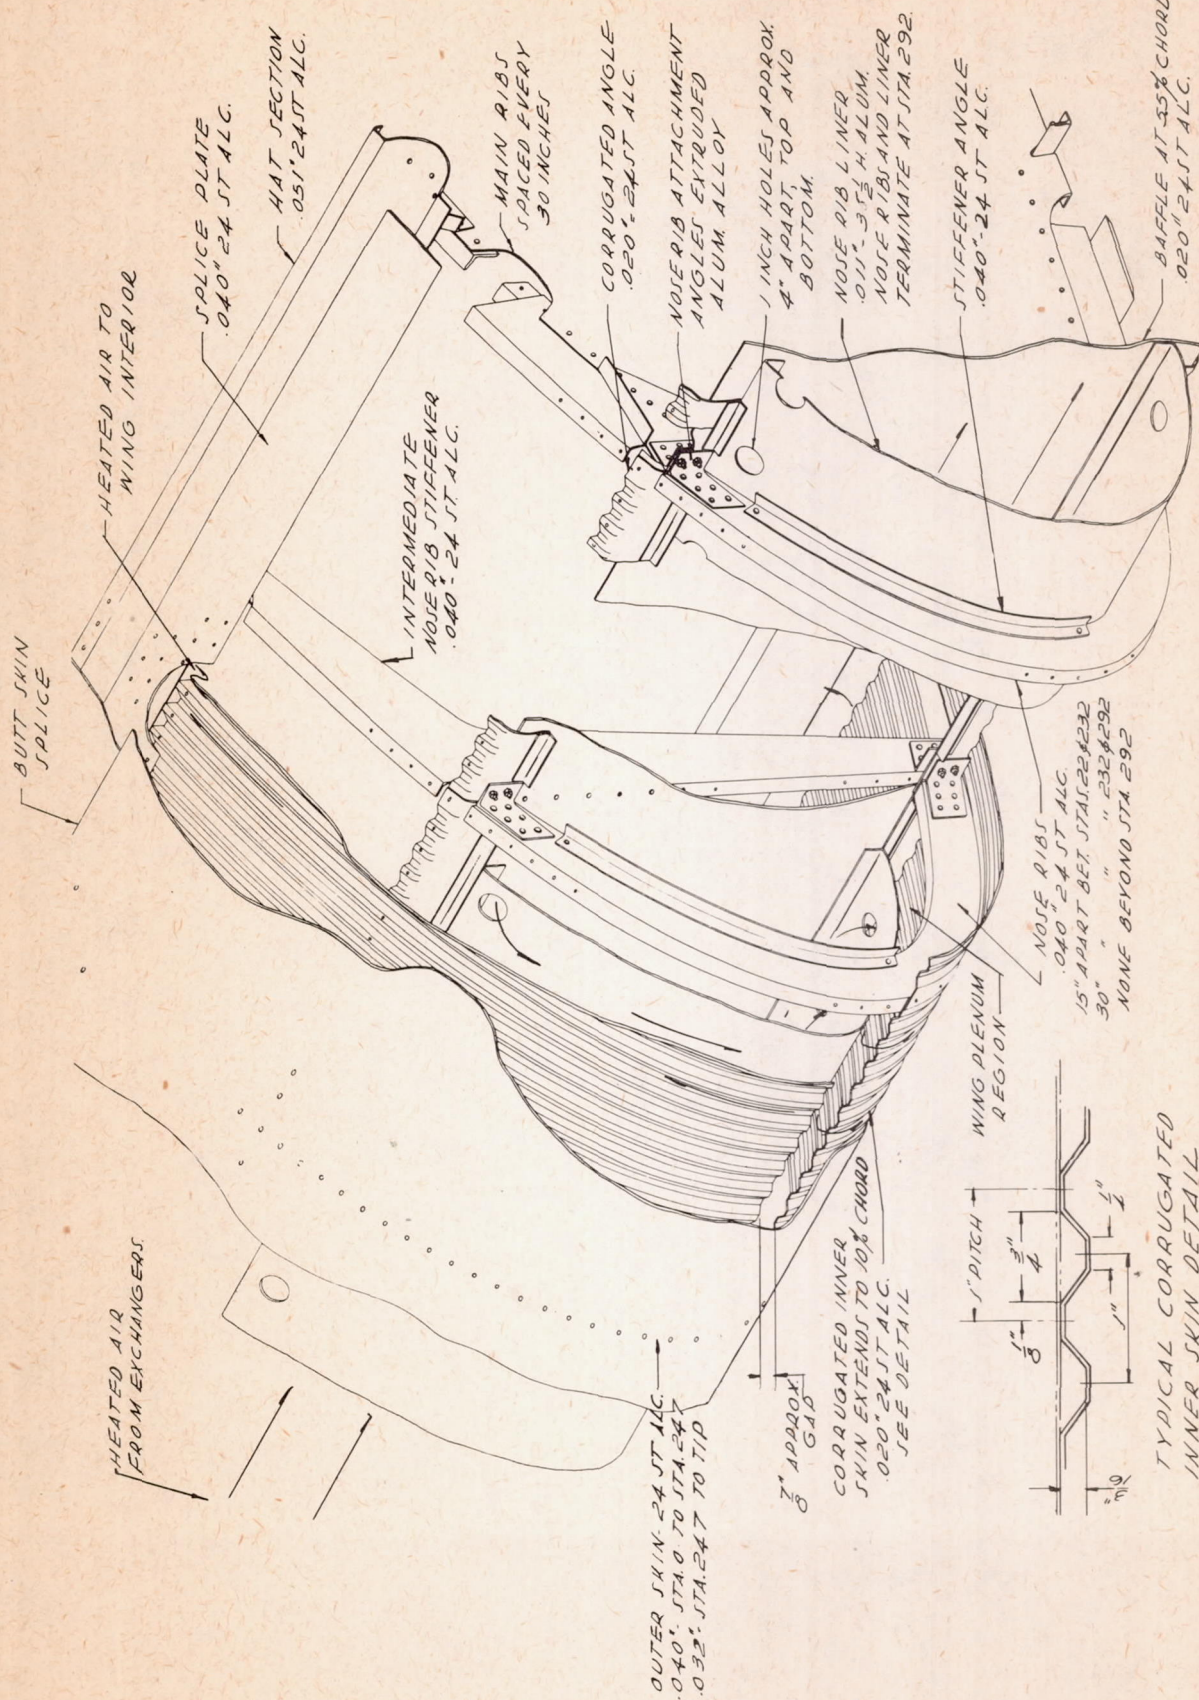
FIGURE 10- TYPICAL WING OUTER-PANEL LEADING-EDGE SECTION AS REVISED FOR THERMAL ICE-PREVENTION, C-46 AIRPLANE.

A typical section of the wing outer-panel leading edge as revised for thermal ice prevention is shown in figure 10. In order to promote the transfer of heat from the internal air to the airfoil skin, the air is caused to circulate against the inner face of the skin by the application of a double-skin system. The inner skin extends rearward from the leading edge to the 10-percent-chord point, and is corrugated in such a manner that a series of chordwise air passages are formed between the inner and outer skin. The heated air enters the chordwise passages through a gap at the leading edge between the upper and lower segments of corrugated inner skin.

Spanwise distribution of the heated air is obtained by means of a duct formed by the installation of a spanwise baffle extending from the upper to the lower corrugated skins and located at approximately 5.5 percent chord. One of the factors influencing the location of the baffle was the fact that the wing main ribs terminated at about 5.5 percent chord and the leading-edge loads were carried by nose ribs forward of that point. The overlapping of the existing main and nose-rib webs precluded the installation of a continuous baffle and, also, the nose-rib webs prohibited spanwise flow of the heated air. The revised design, therefore, incorporated a new set of nose ribs designed to provide a spanwise air passage and a continuous baffle which was easily fabricated and installed. The nose-rib loading is transmitted to the main ribs, or to intermediate nose-rib stiffeners located between the main ribs, through an extruded angle-and-bolt arrangement on each side of the baffle.

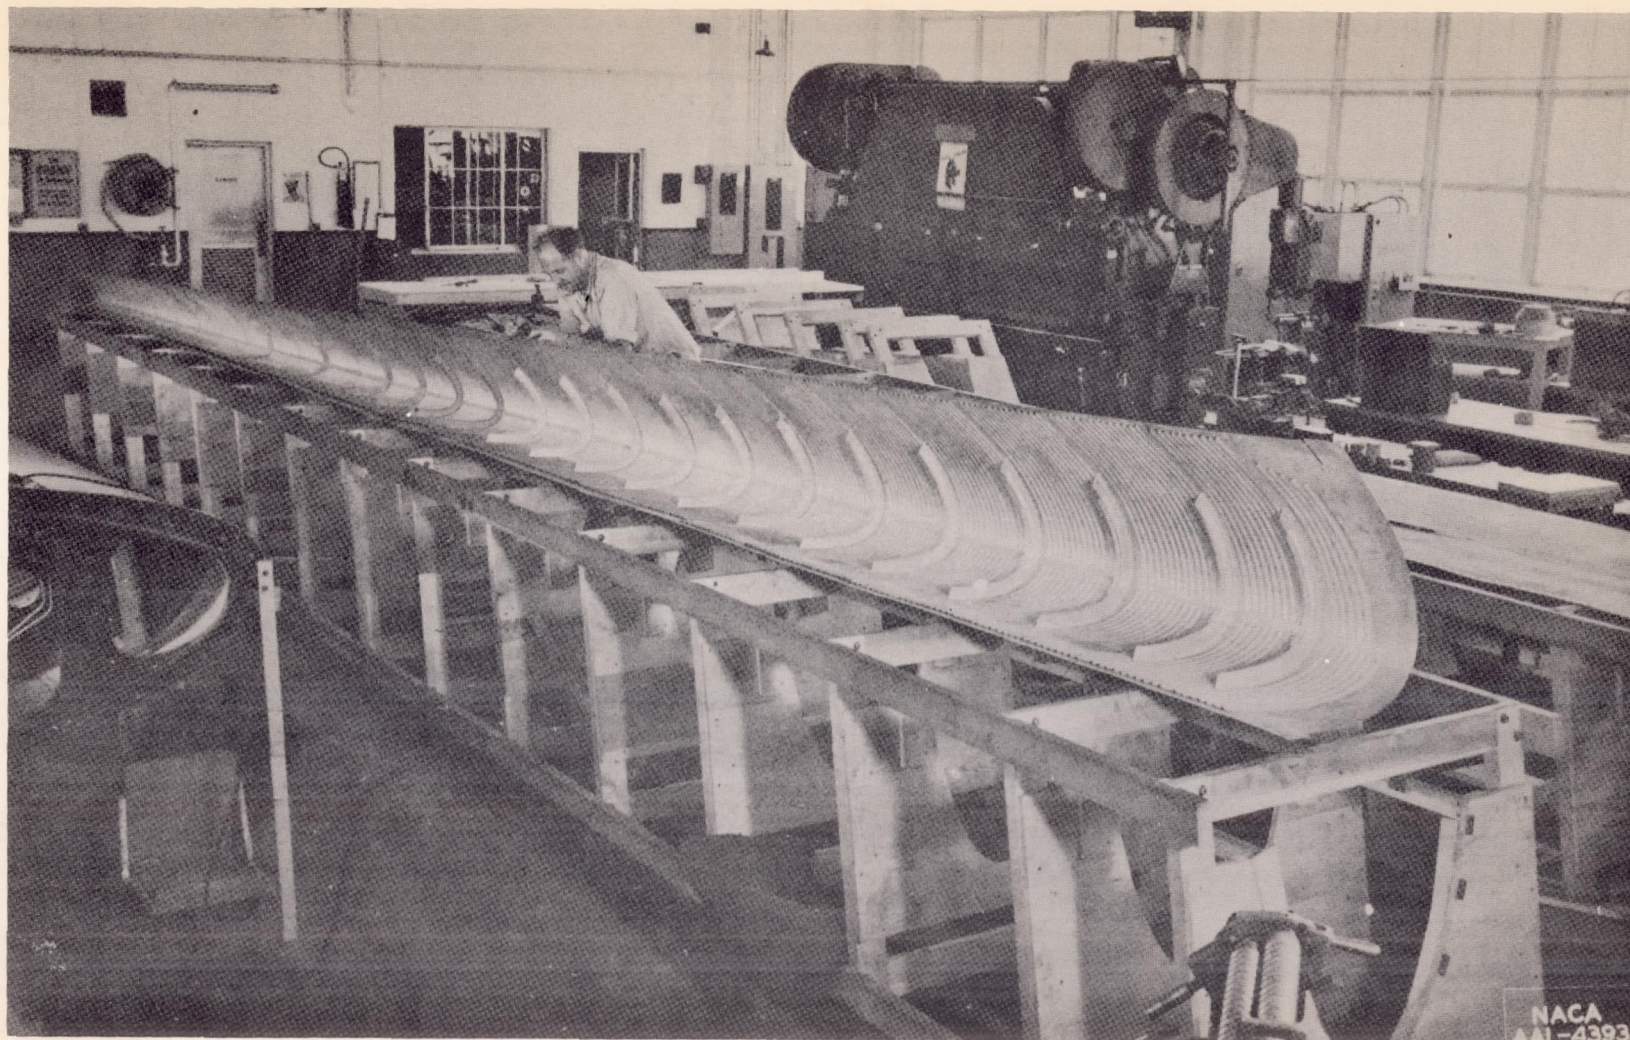
Figure 11.- Corrugated inner skin and revised nose ribs installed in leading edge of left wing outer panel, C-46 airplane.

The left-wing outer-panel leading edge with the inner corrugated skin and revised nose ribs installed is shown in figure 11. The nose ribs are located as follows: one at wing station 11, 15 inches apart from stations 22 to 232, 30 inches apart from stations 232 to 292, and none outboard of station 292. (For wing station locations, see fig. 2.)

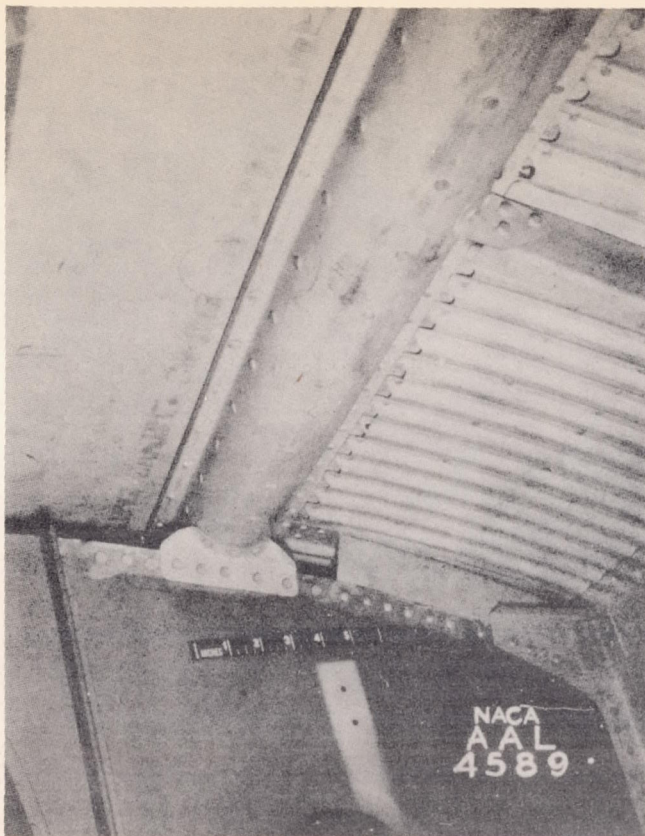
Figure 13.- View showing details of attachment of revised wing outer-panel leading edge to original structure, C-46 airplane.

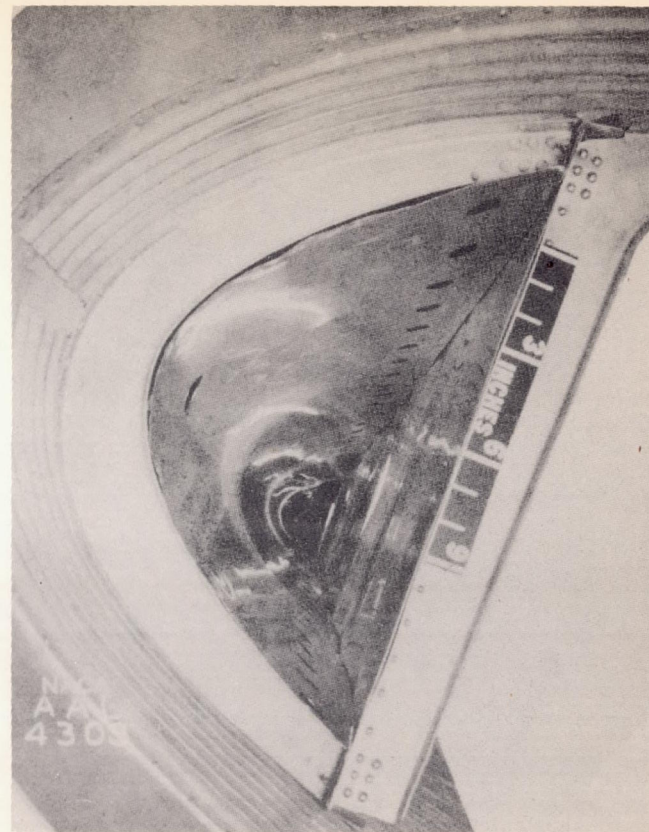
Figure 14.- View of nose liner in right wing outer-panel leading edge from inboard end, C-46 airplane.

The necessity for the addition of the nose-rib liner (fig. 10) to the system was indicated in tests in which air was blown into the revised leading edge before attachment to the wing. The tests, discussed in reference 1, showed that the nose liner was required in order to obtain a spanwise distribution of the heated air which conformed to the distribution found necessary by the design analysis. The nose liner extends spanwise from wing station 11 to the last nose-rib location, station 292. Heated air for the corrugation passages leaves the nose-liner duct through 1-inch-diameter holes spaced approximately 4 inches apart on the top and bottom surface of the liner near the baffle plate (fig. 10). The air then passes through a plenum region between the nose liner and corrugated skin and into the chordwise passages through the leading-edge gap. The 1-inch holes in the nose liner were located near the baffle rather than at the leading edge mainly because of installation difficulties experienced in slipping the liner into position. A view of the nose liner installed in the leading edge of the right wing is shown in figure 14.
